## Patient Safety ALERT:

# Likorall 250 Over Head Hoist – Risk of spreader arm clip failure causing hoist sling detachment

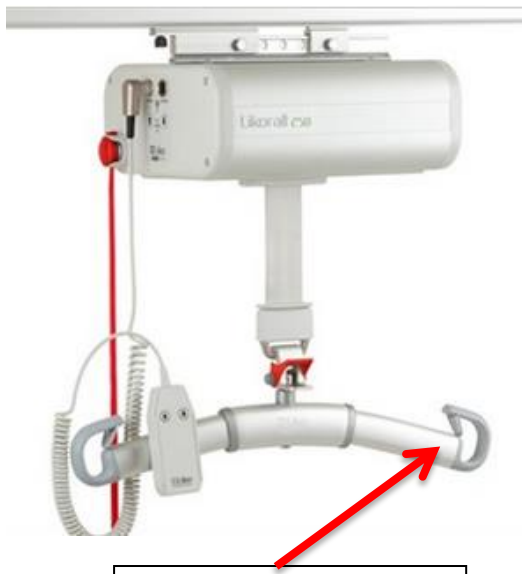
All sling loops should be fed through the clip

With sling in situ ensure all sling loops have passed through the clips. Raise the boom to take up the tension. Check all loops and clips are correctly positioned.

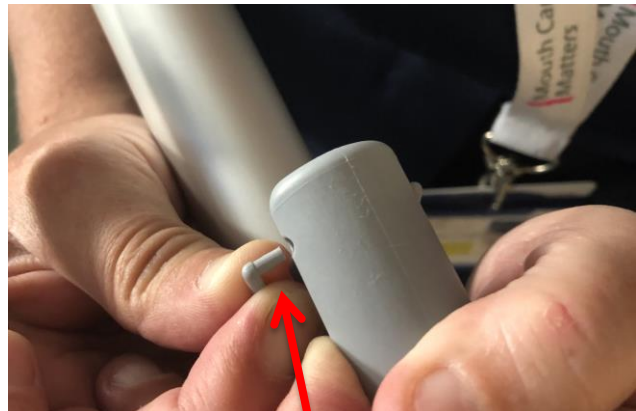
If the safety clip pin detaches and 'pings off'. Do not use, label 'out of order'. Complete an incident report (Datix). Report to Hillrom.

- Do not continue to use the hoist.
- Label the hoist as 'Out of Order' and inform the nurse in charge.
- Complete an Incident Report Form (Datix).
- Report issue to Hillrom Customer Service on 01530 411 000 (8:00-17:15 weekdays). Out of hours a message can be left.
